TCREC TECHNICAL REPORT 62-111

HELICOPTER ROTOR BLADE EROSION
PROTECTIVE MATERIALS

December 1962

VERTOL DIVISION
The Boeing Company
Morton, Pennsylvania

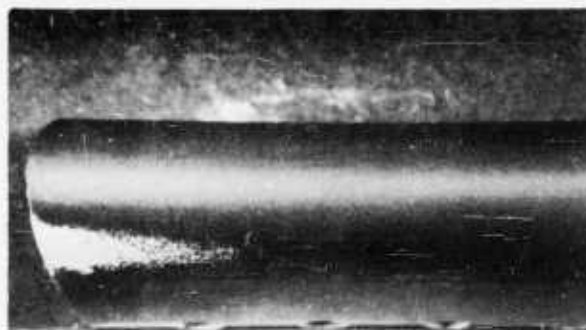
Figure 44. BV 65-221.
Polyvinyl Chloride Pressure Sensitive Tape.
Thickness, .020 In.
Duration of 1/2 Run.

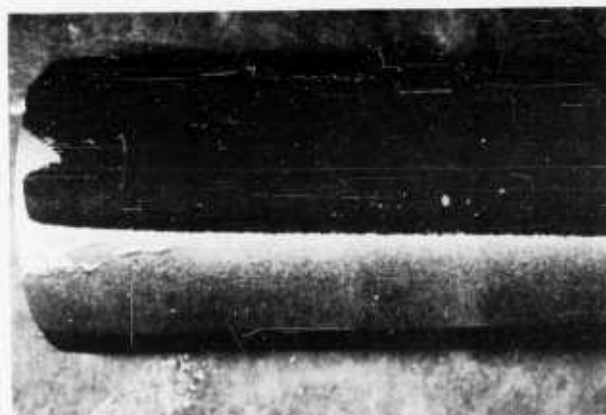
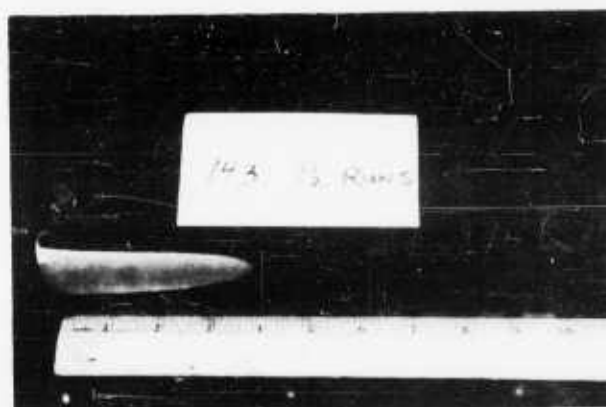
Figure 51. BV 143-221-2.
Polyvinyl Chloride Over Full Hard 301SS.
Thickness, .020 + .009 In.
Duration of 1-1/2 Runs.

Since the best polyvinyl chloride tape resisted erosion on the nose and the 301 full hard stainless steel showed light erosion on the flanks of the specimens after testing, a combination specimen of these two materials was tested. Separately, each material had a wear life of 1/2 run; however, the combination specimen, with tape over the stainless, exhibited a wear life of 1-1/2 runs - Appendix I, Figures 50 and 51).

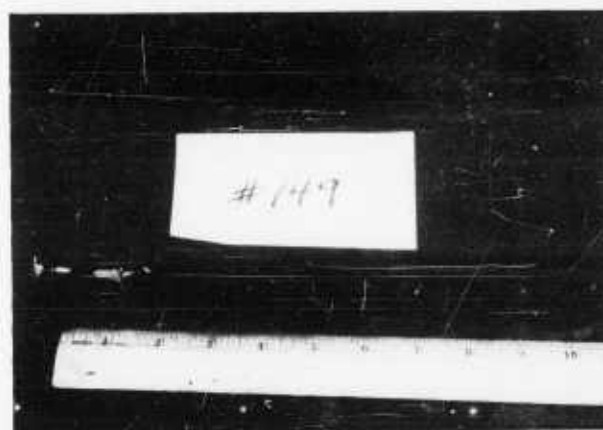
Figure 54. BV 149-148.
Polysulfide.
Thickness, .012 In.
Duration of 1 Run.

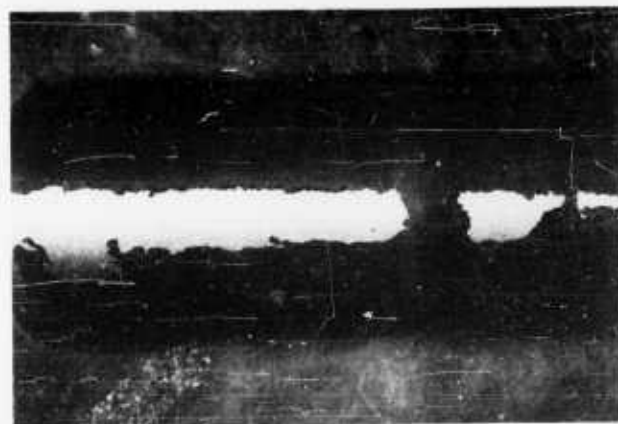
Figure 55. BV 162-170.
Polyurethane.
Thickness, .020 In.
Duration of 1 Run.

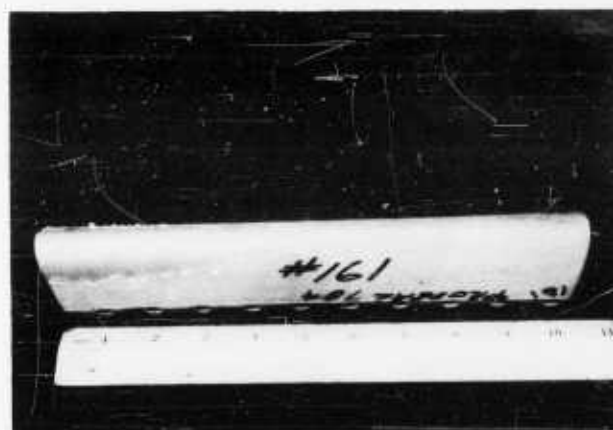
Figure 56. BV 161-172.
Polyurethane.
Thickness, .020 In.
Duration of 1 Run.

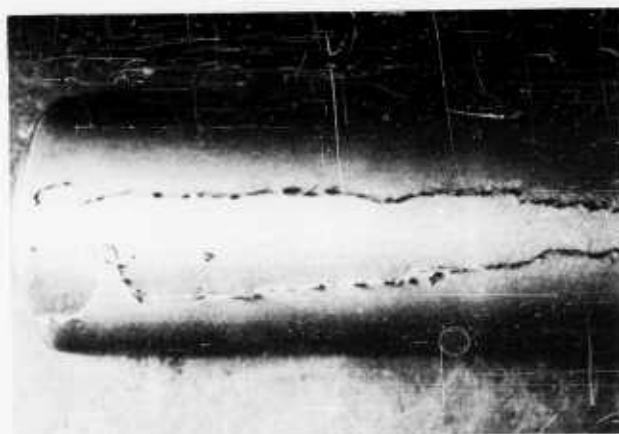
Figure 57. BV 160-173.
Polyurethane.
Thickness, .020 In.
Duration of 1 Run.

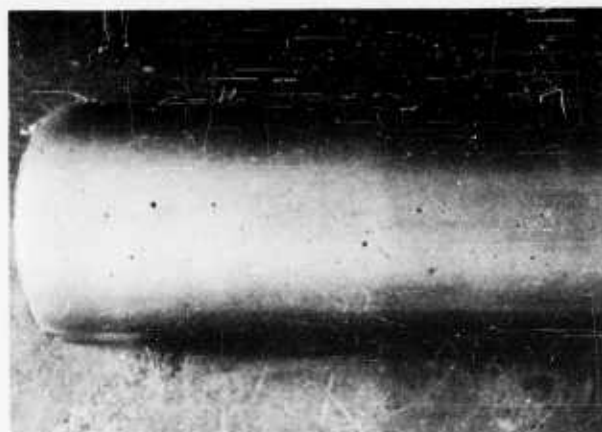
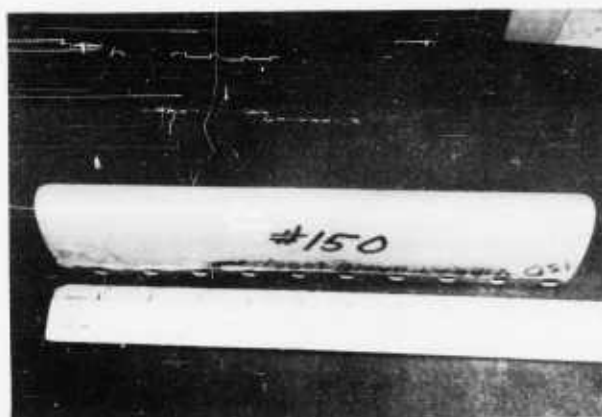
Figure 59. BV 140-168.
Polyurethane.
Thickness, .020 In.
Duration of 1 Run.
